ST. MARY'S RIVER WATERSHED  
SITE NO. 1

PHASE I INSPECTION REPORT  
NATIONAL DAM INSPECTION PROGRAM

July 1980

ST. MARY'S RIVER WATERSHED, SITE NO. 1  
NDI ID NO. MD-28

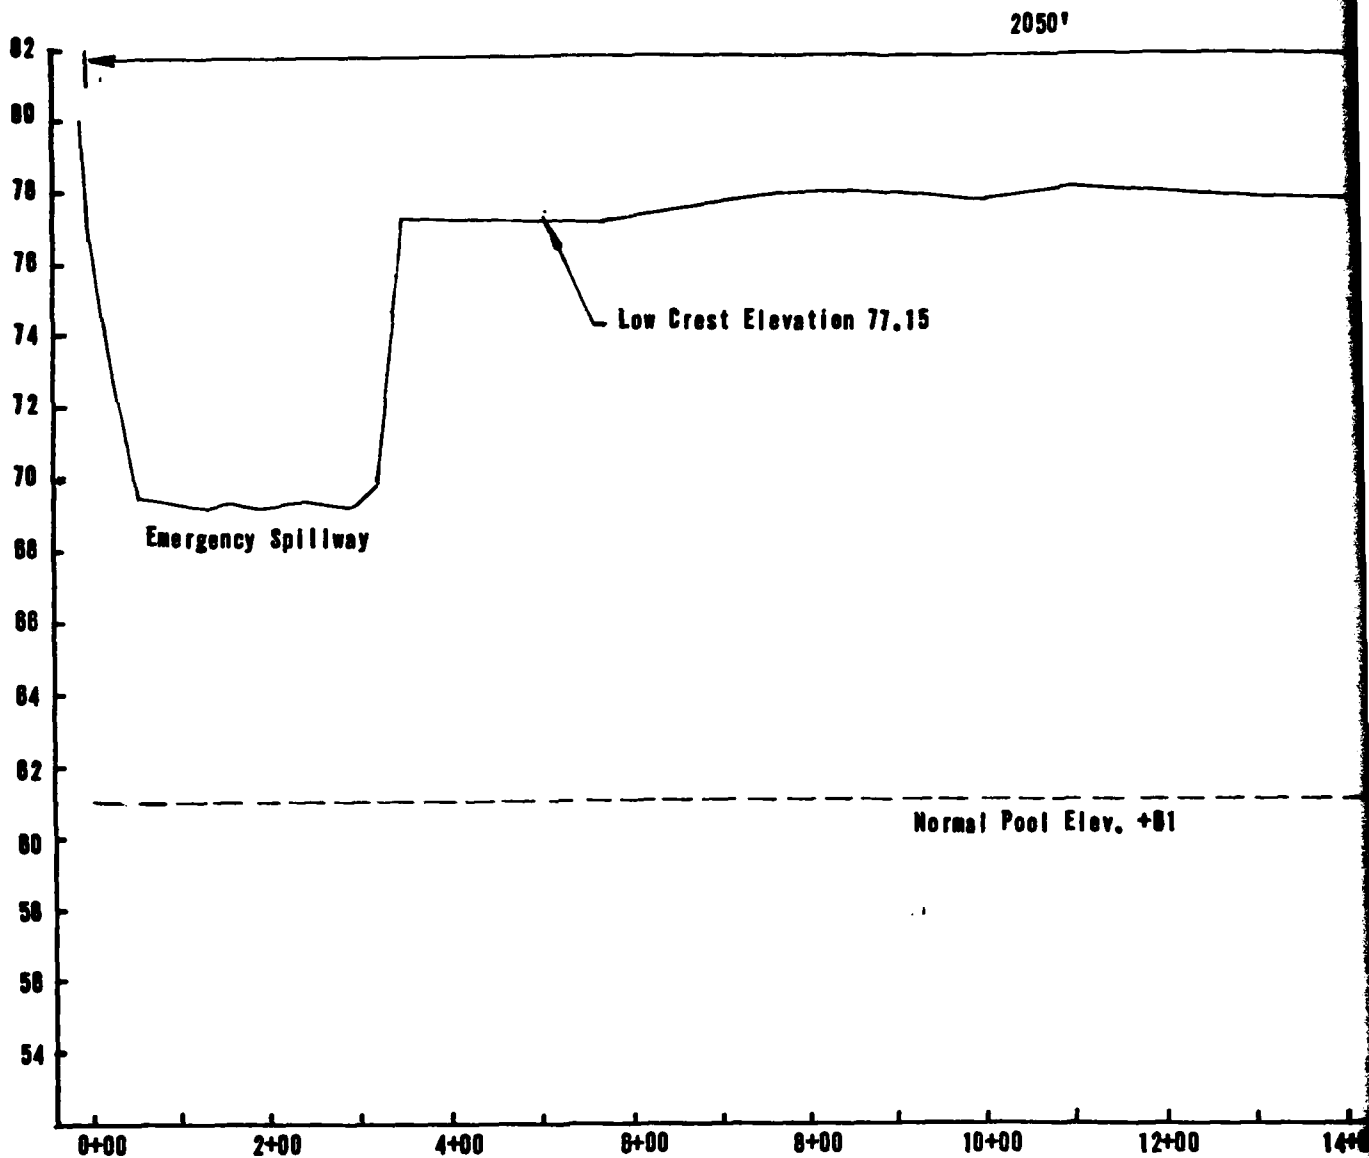
## DAM CREST SURVEY

The crest of the dam was surveyed and the variance in elevation was 10.5 inches between the high and low point. Also, the low point on the crest is 0.6 inches above the design dam crest elevation of 77.1 feet above m.s.l. It should be noted that the crest elevations were referenced to a pin set by the U.S. Soil Conservation Service in a tree along the right abutment of the dam. Freeboard at the time of inspection was approximately 16 feet, and under design maximum pool conditions would be approximately 5.9 feet. The dam crest profile is included on Plate A-2.
